CHAMPION AIRCRAFT CORPORATION  
Osceola, Wisconsin

SERVICE LETTER #20

SUBJECT: Installation - Instructions - "No-Bounce" landing gear oleo assembly.

AIRPLANES AFFECTED: Optional modification of any Model 7AC, 7BCM, 7CCM, 7DC or 11 series airplane.

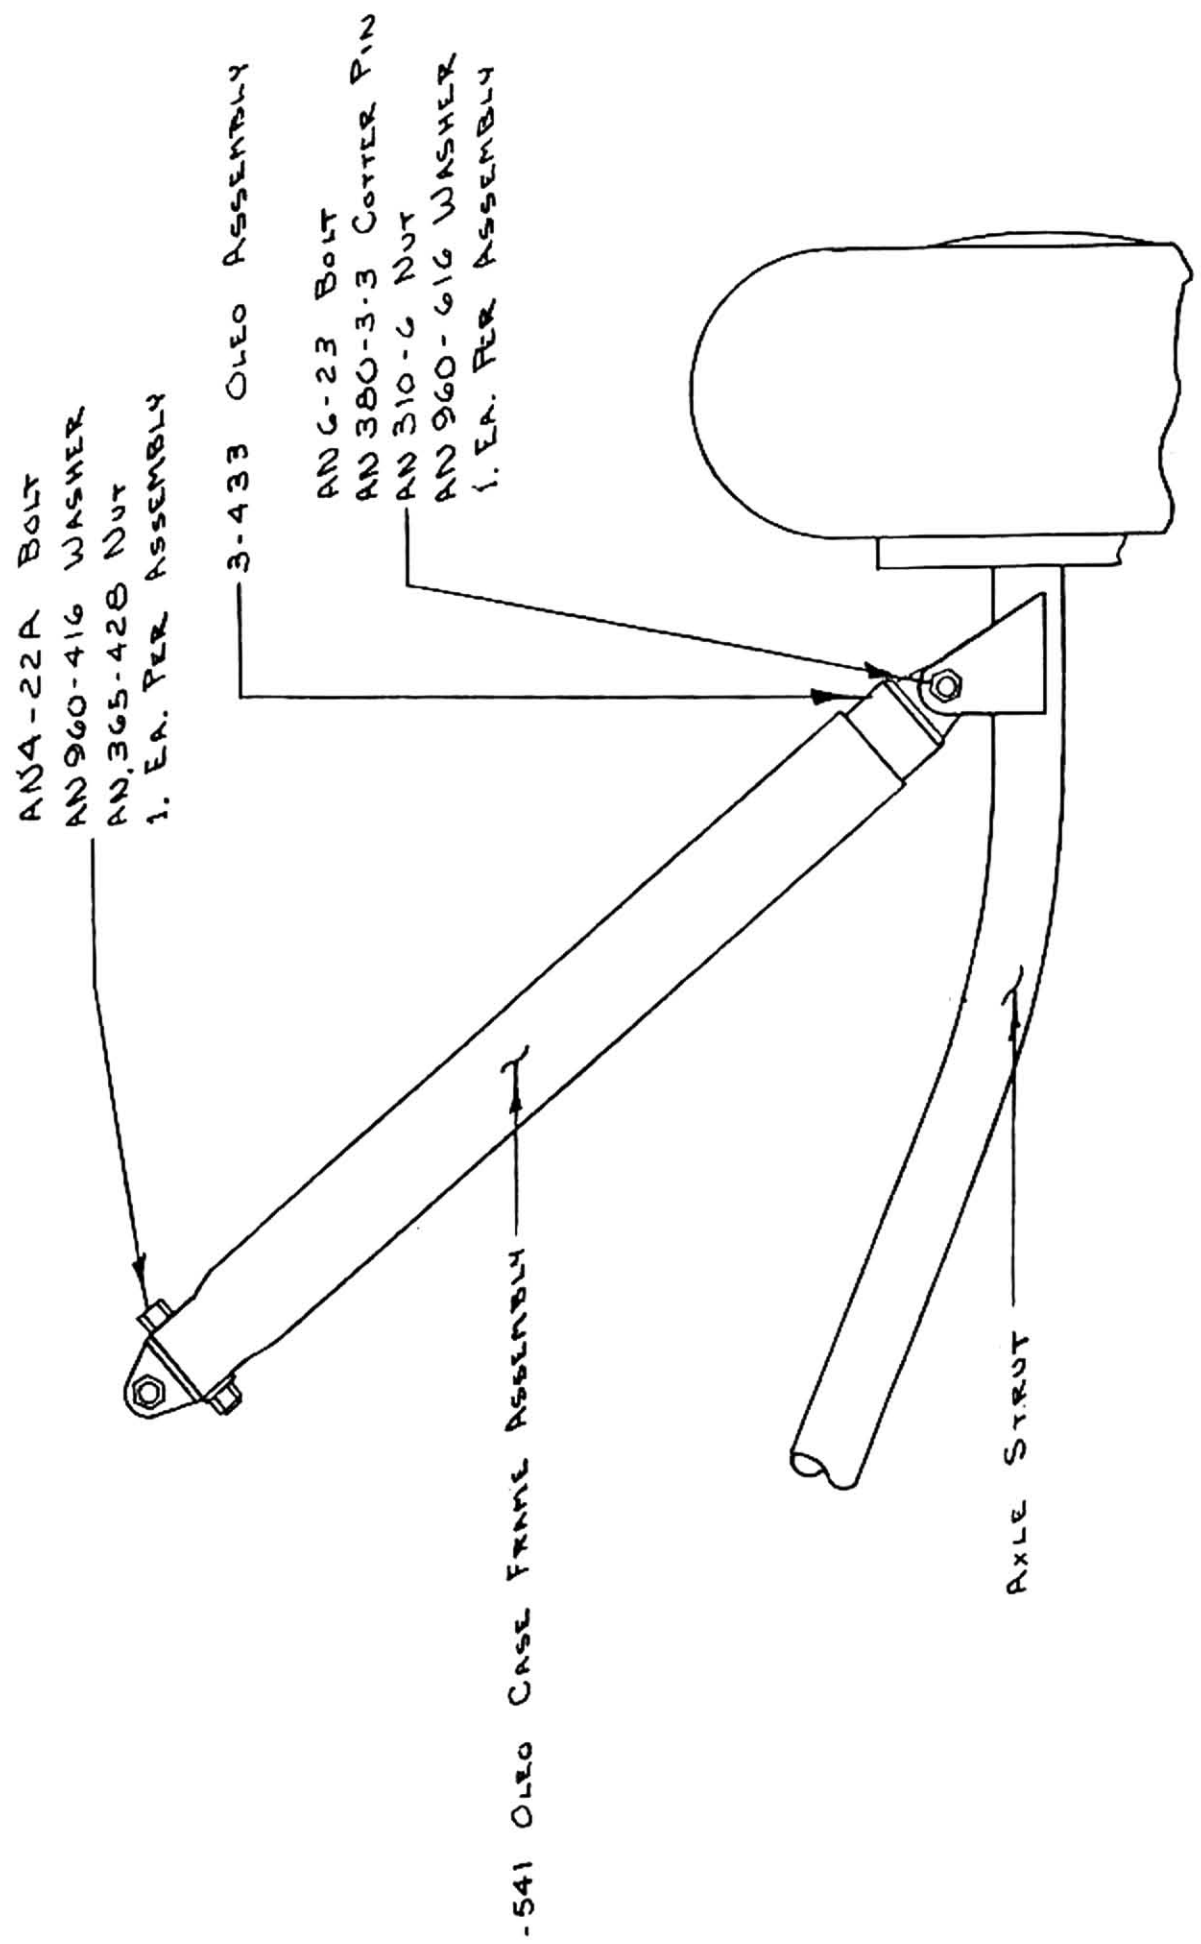
FIGURE NO.1 FOR USE WITH SERVICE LETTER NO. 20.

1. Jack up the airplane so that all weight is removed from the landing gear.
2. Remove the AN365-482 nut, AN960-416 washer and AN4-22A bolt, located in the upper end of the 2-700 (2") forward Strut, or the 4-541 oleo case frame assembly. (See Figure 1).

3. Remove the AN380-3-3 cotter pin, AN310-6 nut, AN960-616 washer and AN6-23 bolt, attaching the lower end of the 3-433 oleo assembly, to the axle strut. (See Figure 1).

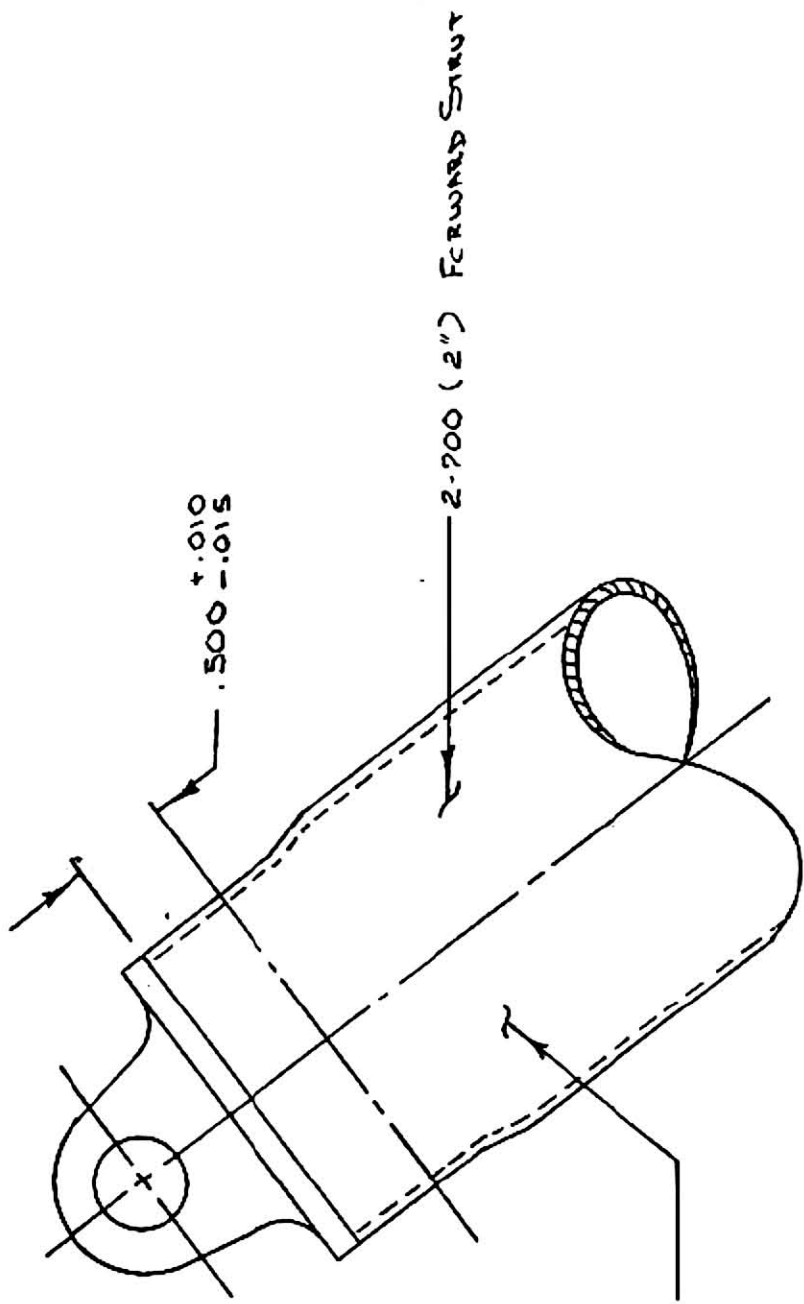
FIGURE No: 2 FOR USE WITH SERVICE LETTER No. 20

.3125<sup>+.001</sup> LINE REMN TARN.  
C.L. OF HOLE MUST PASS WITHIN  
.002 OF TUBE C.L. AND BE SQ.  
WITH C.L. OF TUBE WITHIN .002

4. Remove the 3-433 oleo assembly from the 4-541 oleo case frame assembly.
5. Line ream the  $\frac{1}{8}$  inch diameter hole, in the upper end of the 2-700 (2") forward strut, of the 4-541 oleo case frame assembly to  $3125^{+.001}$  Diameter. (See Figure 2).
