AERONCA AIRCRAFT CORPORATION

SERVICE LETTER NO. 22

SUBJECT: Improved Model 15AC firewall door catch (Ambulance - Cargo - Seaplane).

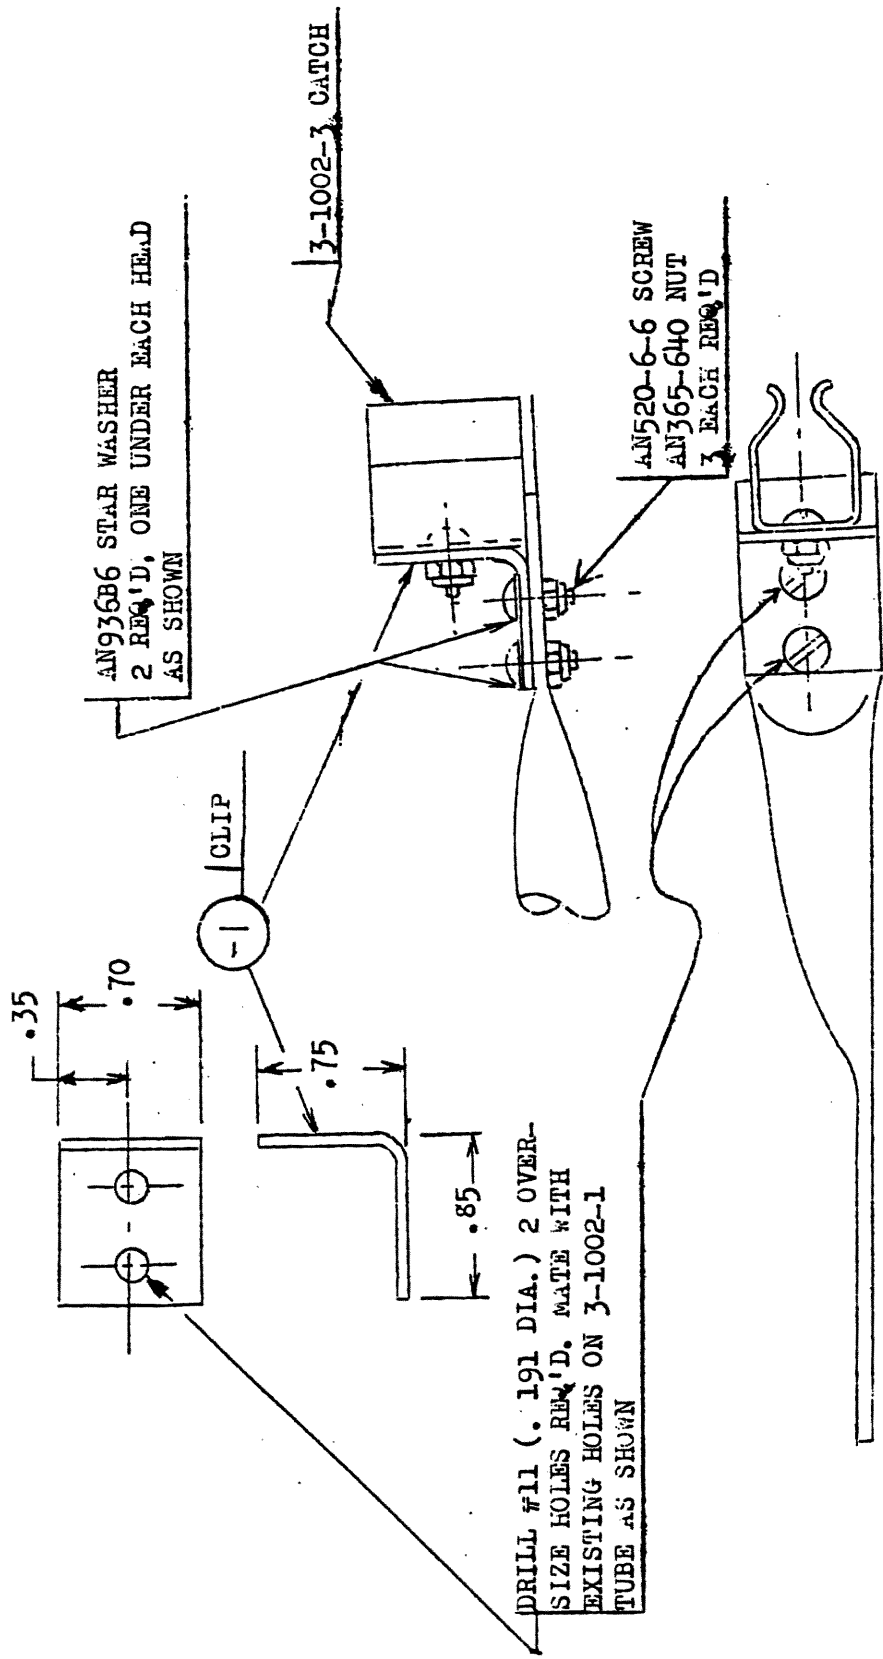
SKETCH #1 FOR USE WITH SERVICE LETTER NO. 22

A simple modification of any existing firewall door catch will greatly improve the service life of the catch and at the same time provide more spring tension to keep the door open in higher cross winds.

1. Remove the existing female spring catch from the firewall tube.
2. Fabricate a "-1" clip (See sketch).
3. Install a 3-1002-3 female spring catch on the "-1" clip (See sketch).
4. Install the clip-catch combination on the firewall tube. NOTE: The oversize holes in the "-1" clip will permit enough play to insure direct alignment of the new 3-1002-3 female spring catch with the male catch on the door.

AN936B6 STAR WASHER  
2 REQ'D, ONE UNDER EACH HEAD  
AS SHOWN

3-1002-3 CATCH

AN520-6-6 SCREW  
AN365-640 NUT  
3 EACH REQ'D

DRILL #11 (.191 DIA.) 2 OVER-  
SIZE HOLES REQ'D. MATE WITH  
EXISTING HOLES ON 3-1002-1  
TUBE AS SHOWN

-1 CLIP MATERIAL STEEL, STOCK; .040 x 1.60 x .75

FINISH: - ZINC CHROMATED AND DOPED
