CHAMPION AIRCRAFT CORPORATION
Osceola, Wisconsin

SERVICE LETTER #3

Effective on all Models: 7A - 7B - 7C - 7D - 7E - 11A - 11B - 11C

SUBJECT: Wing Tip Bow Repair

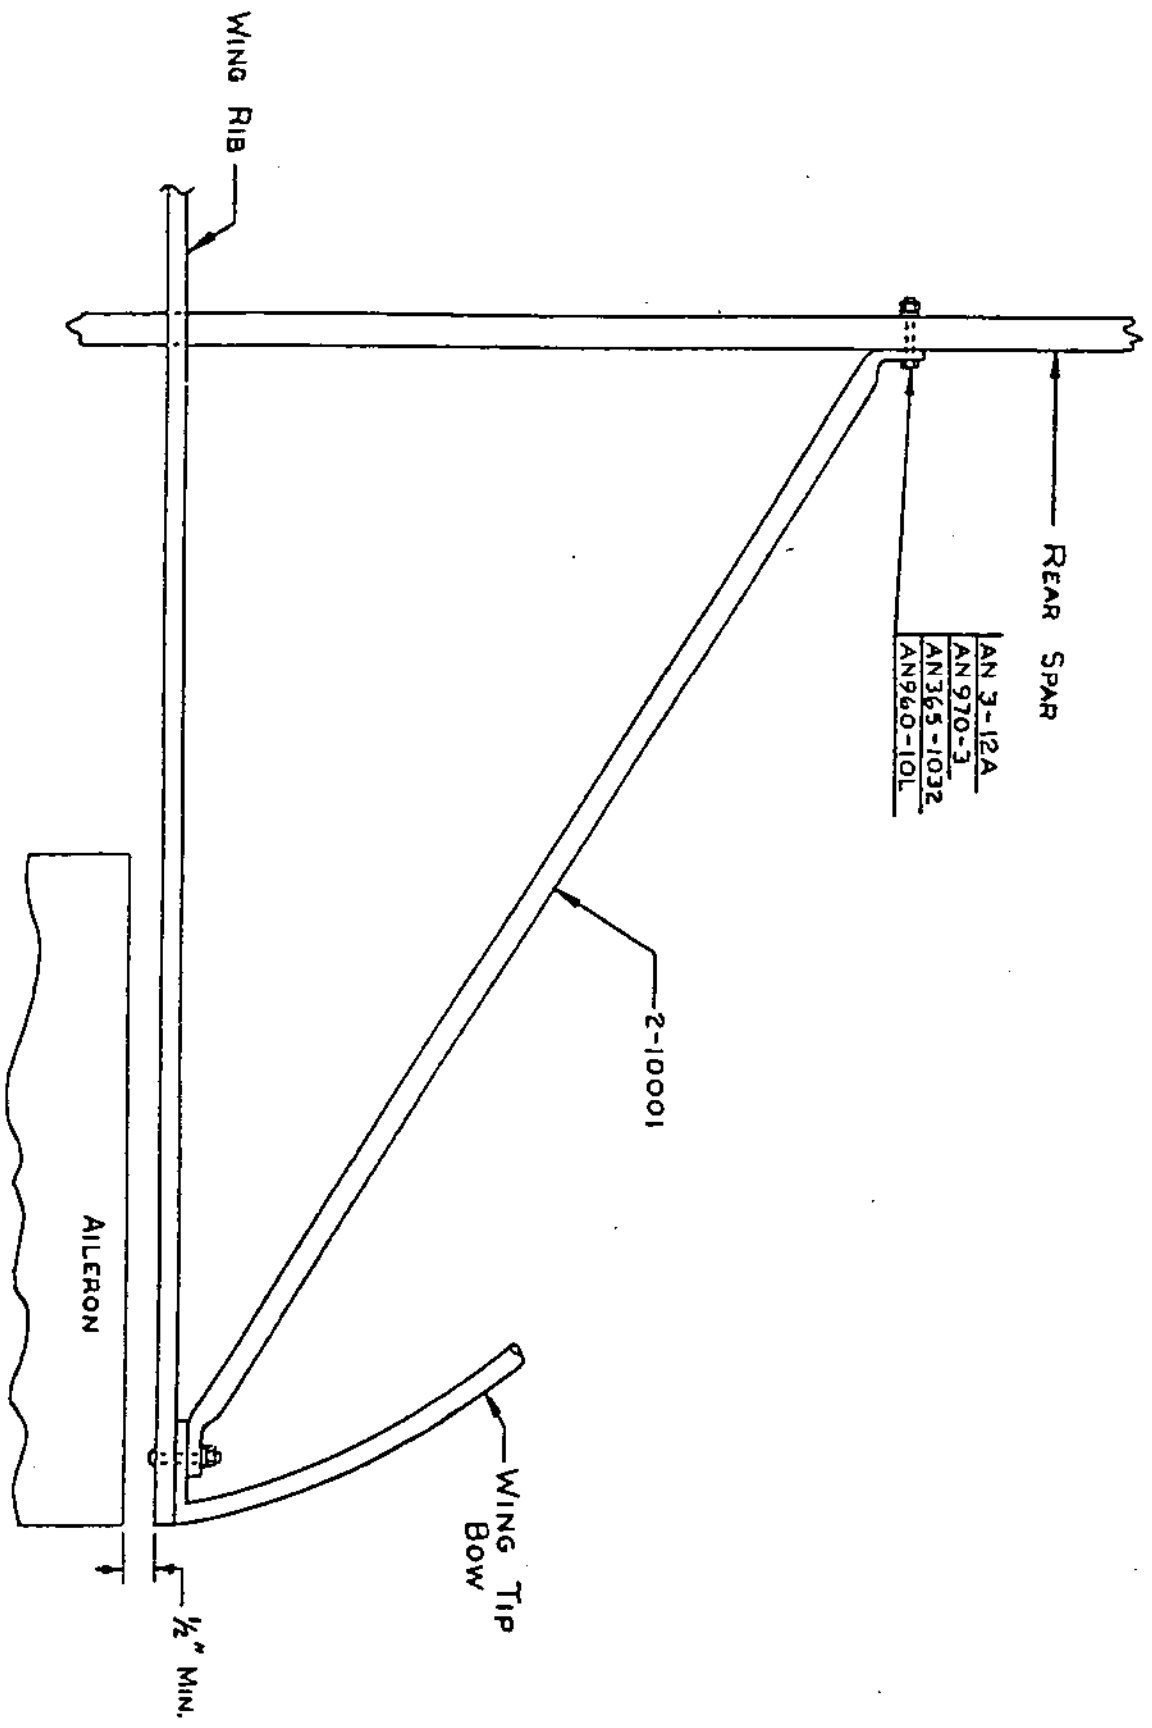
CHAMPION AIRC. CORP.
SERVICE LETTER # 3

Fabric shrinkage (or striking the wing tip on some object) causes the tip of the Wing Tip Bow to move inboard, reducing the aileron clearance.

Remove fabric as needed. Attach end of 2-10001 brace at tip of Wing Tip Bow as shown. (Replace washer under head of nut). Move tip of Wing Tip Bow outboard sufficiently to obtain 1/2" aileron clearance. Drill through spar at center with a #6 drill. Touch up spar with spar varnish. Attach 2-10001 to spar as shown.
