SERVICE LETTER 404

SUBJECT: Aileron Hinges

APPLICABLE MODELS: All 7 Series Aircraft with 1000+ Hours

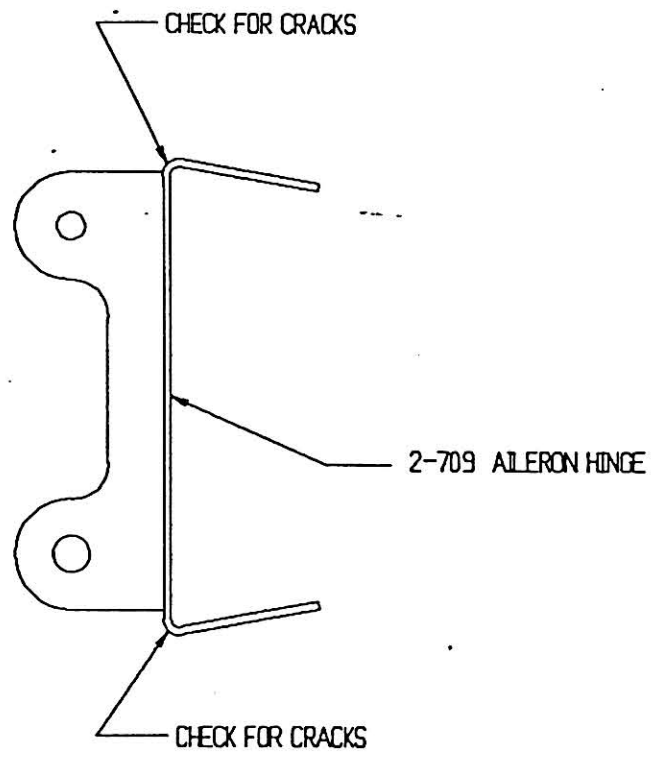
FIG. 1

DESCRIPTION: There have been reports of cracks on the inboard aileron hinges, part number 2-709, used on all of the 7 series aircraft. These reports state that cracks are being found at either tab end of the most inboard aileron control hinge. The cracks appear on the outside bend radius of the upper and lower tabs. There have also been reports of tab failure.

- 1.) Before further flight, perform a visual inspection of the aileron hinges for evidence of cracks (see fig. 1). This will require the removal of a small amount of fabric in the hinge area.
- 2.) If the cracks are found, replace the hinge with part number 2-709.
- 3.) If no cracks are found, inspect the hinge at each annual or every 100 hours.
