American Champion Aircraft Corp.  
Rochester, WI 53167

Service Letter: 426 (page 1 of 2)

Title: Inspection / Upgrade of Wing Tip Navigational Light Wires

Models: All Bellanca/American Champion model 7's and 8's built before August 1996 that have strobe and navigation wires running to the wing tip.

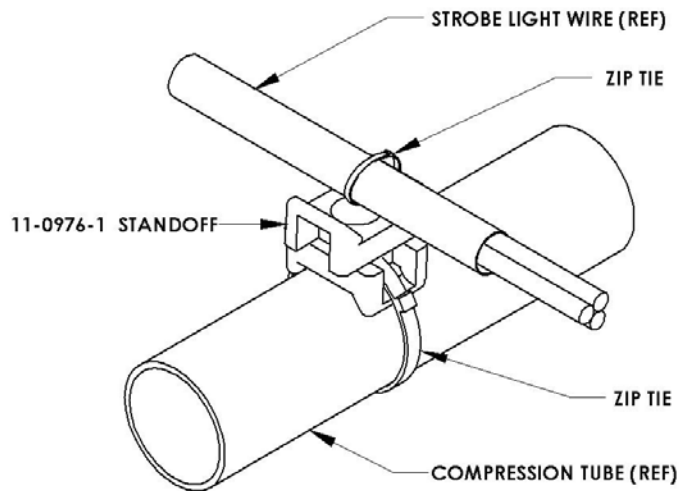
Description: Previous to August 1996, all aircraft with wing tip lights routed the wires down the center of drag truss of the wing. The wires were attached to the compression tubes with adhesive fabric tape. With time, this tape becomes brittle and can fail, allowing the wire to wear against the compression tube. There have been numerous reports of the wire chaffing through its insulation and grounding, blowing the fuse or popping the breaker.

**Figure 1, View of Wire and Standoff on Compression Tube**

To preclude wire chaffing, wire standoff should be installed to separate the strobe and navigation wires from the compression tubes. Install ACA P/N 11-0976-1, or equivalent, wire standoff directly on top of each compression member where the wire crosses using one zip tie (P/N: PLT 2S-MD or equivalent) around the compression member as seen in Figure 1. The standoff should be rotated 90 degrees to allow it to seat on the compression tube and allow the wires to be zip tied to the standoff. Zip tie (P/N: VUVT 06M M or equivalent) the wires to one side of the standoff (see Figure 1) tight enough to prevent slip between the wires and zip tie. Leave some wire slack between each standoff.
